**NL INDUSTRIES/TARACORP SUPERFUND SITE GROUP**  
**2209 Quarry Drive, Suite C-35**  
**Reading, PA 19609**  
**Telephone: (610) 670-7310**  
**Facsimile: (610) 670-7311**

December 1, 2020

**Re: NL Industries/Taracorp Superfund Site; Granite City, Illinois**  
**Second 2020 Semi-Annual Operation and Maintenance Inspection (November 9, 2020)**  
**Annual Site Visit (November 10, 2020)**

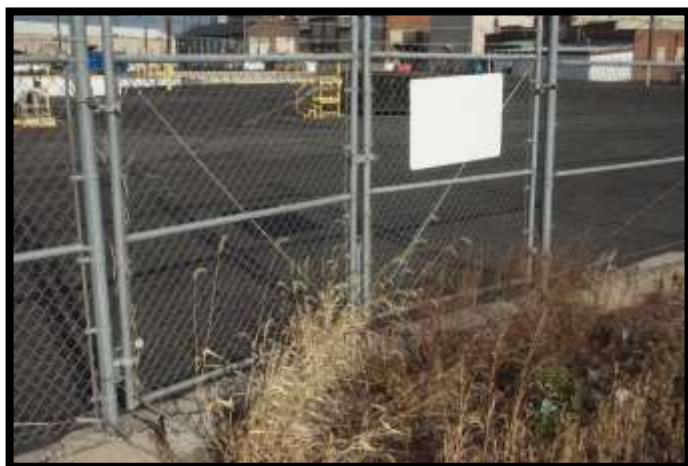
Photograph 21: Fence, warning sign, western side of Taracorp pile.

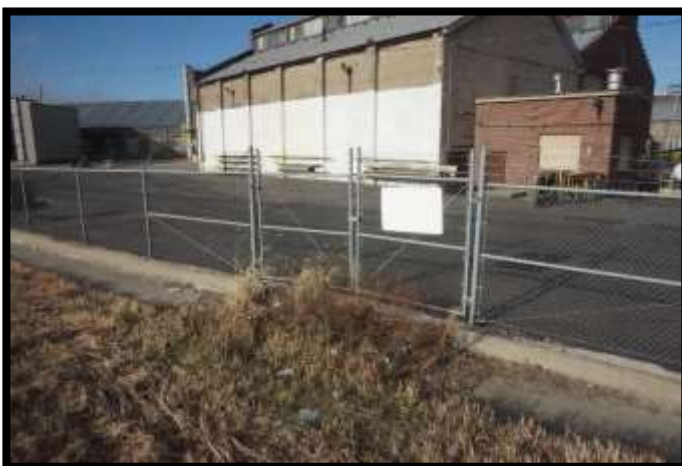
Photograph 22: Fence, warning sign, western side of Taracorp pile.

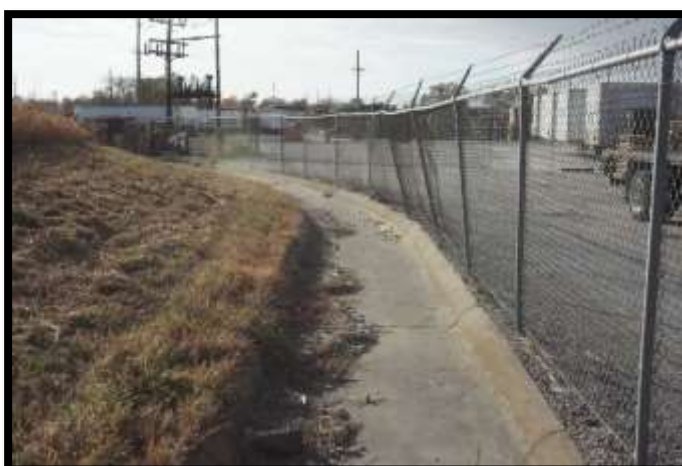
- All Pallet Services, one of the companies that operates on the main industrial site, completed work to repair a bent section of fence (Attachment 5, photographs 30, 31, and 39-41) and to remove most of its pallets from the area near the State Street Warehouse side of the property. There is still some remaining work to be completed in this area, such as repairing a separated fence post (Attachment 5, photographs 40 and 43) and repairing some torn barbed wire (Attachment 5, photographs 42-44), but the condition of the fence is improved and no impacts to the effectiveness of the remedy were observed.

Photograph 30: Concrete drainage swale and vegetation near base of western side of Taracorp pile (view south).

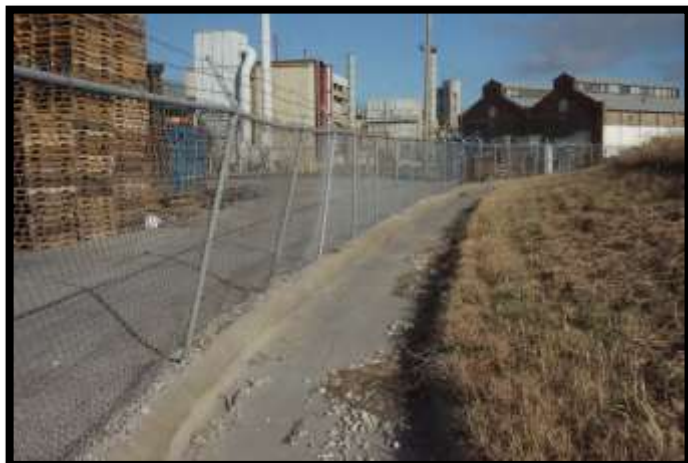
Photograph 31: Fence and concrete drainage swale, southwestern side of Taracorp pile cap (view north).

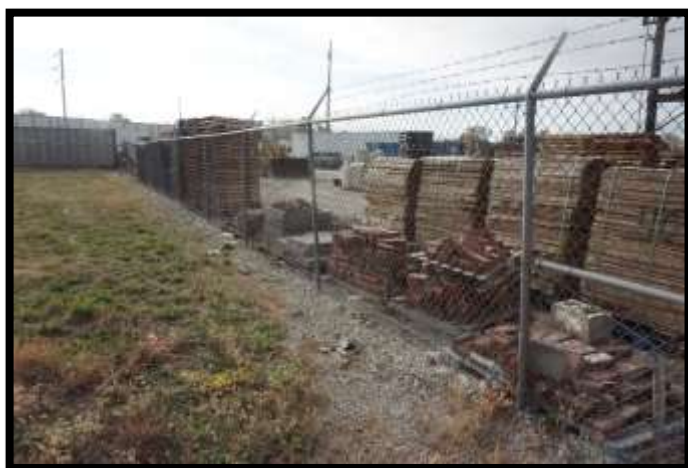
Photograph 39: Fence along State Street Warehouse storage area.

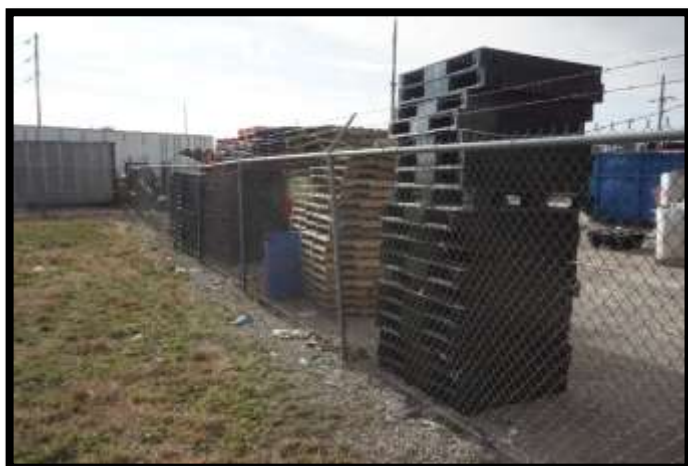
Photograph 41: Fence along State Street Warehouse storage area.

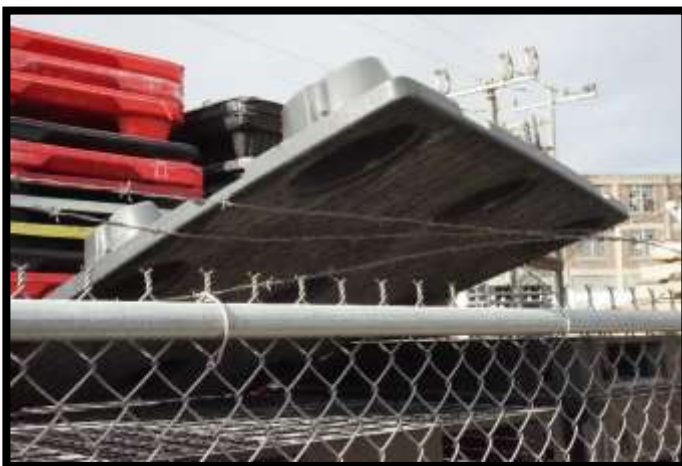
Photograph 42: Plastic pallet on barbed wire/fence along State Street Warehouse storage area.

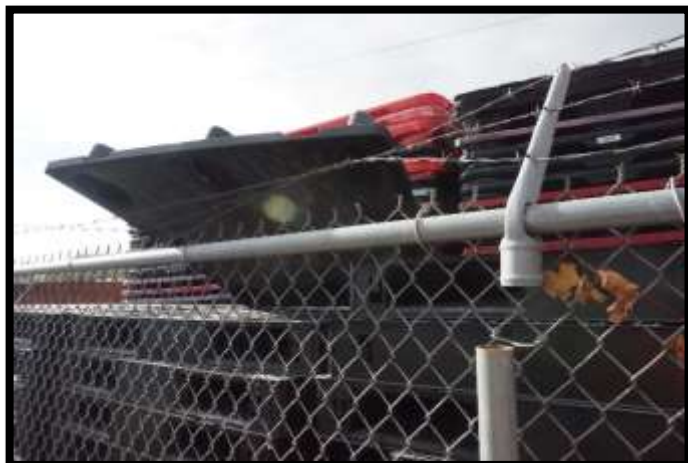
Photograph 43: Plastic pallet on barbed wire/fence along State Street Warehouse storage area.

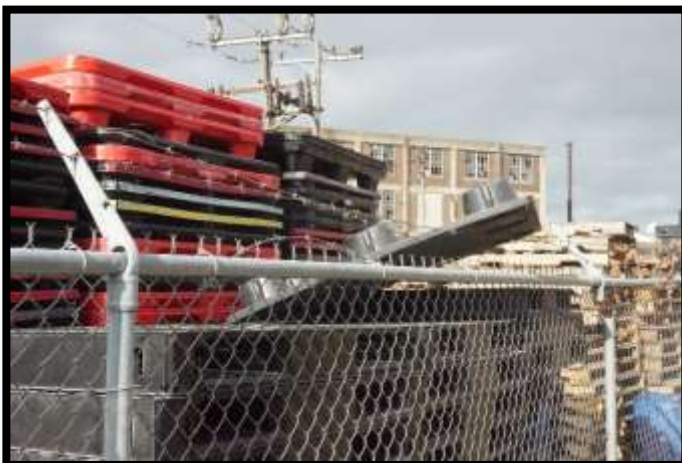
Photograph 44: Plastic pallet on barbed wire/fence along State Street Warehouse storage area.

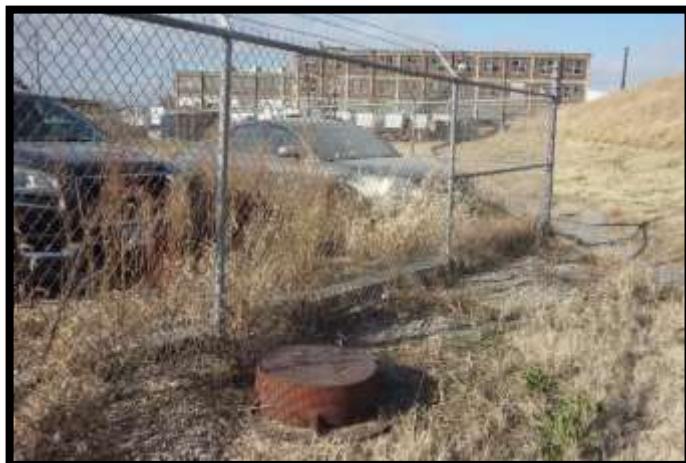
Photograph 55: Stormwater manhole near fence.

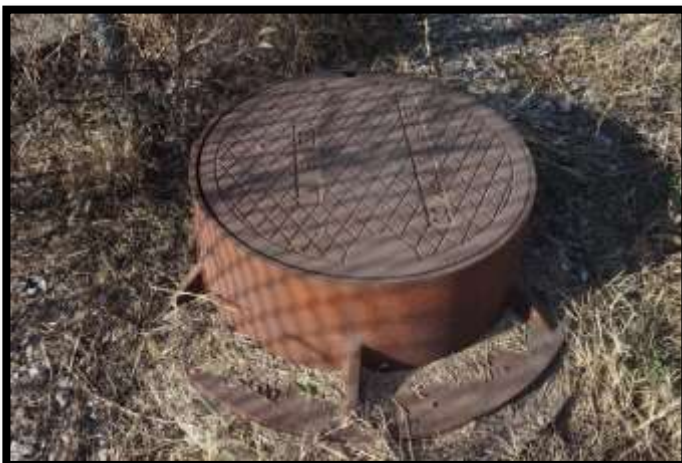
Photograph 56: Stormwater manhole.

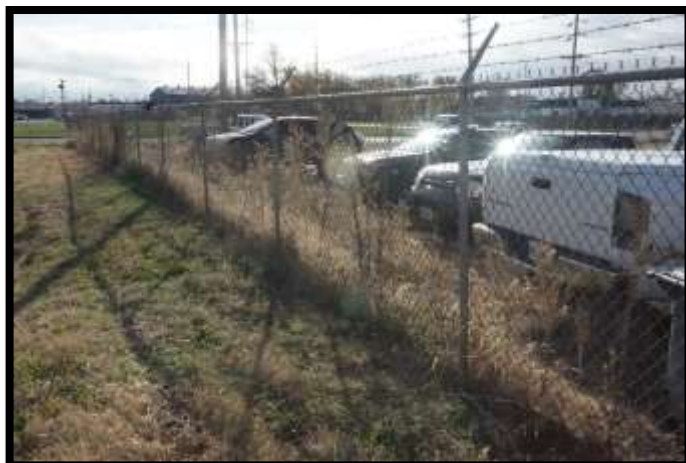
Photograph 57: Vegetation and fence near former Rich Oil facility (view toward State Street).

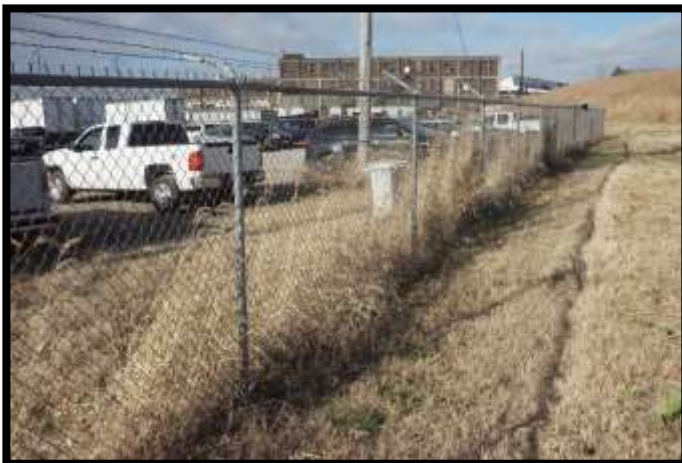
Photograph 58: Vegetation and fence near former Rich Oil facility (view from State Street).

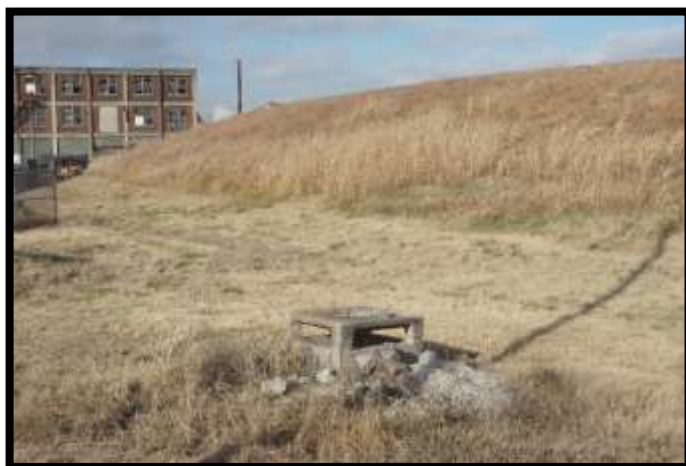
Photograph 59: Vegetation, southeastern side of Taracorp pile cap.

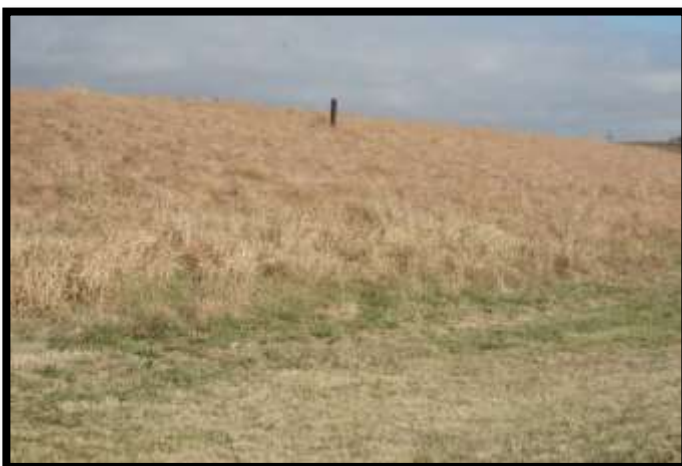
Photograph 60: Vegetation, eastern side of Taracorp pile cap.

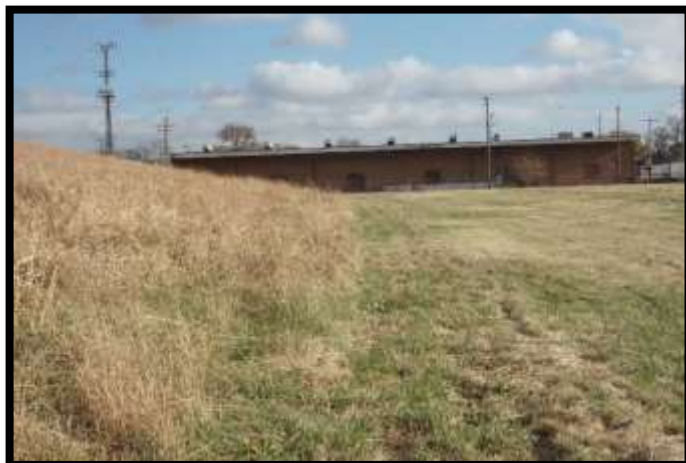
Photograph 61: Vegetation, eastern side of Taracorp pile cap.

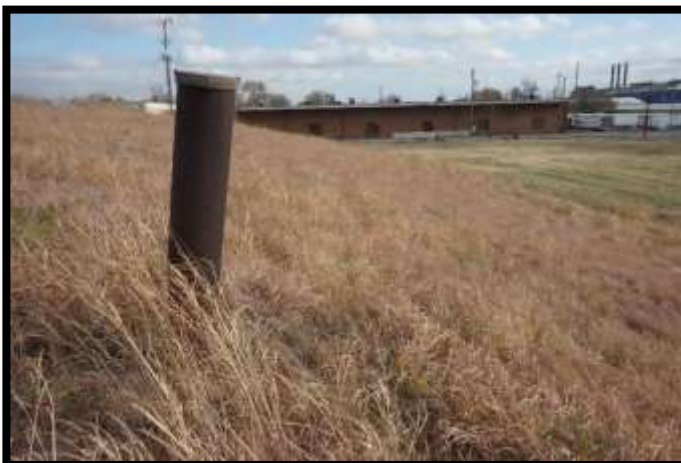
Photograph 62: Leachate riser pipe.

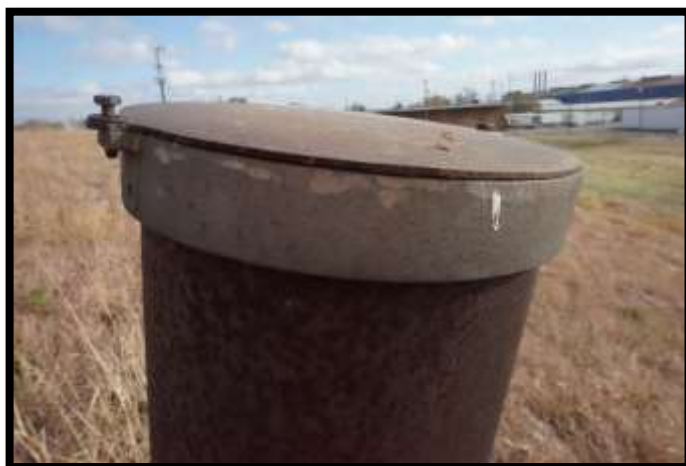
Photograph 63: Locked lid on leachate riser pipe (locked lid installed fall 2007).

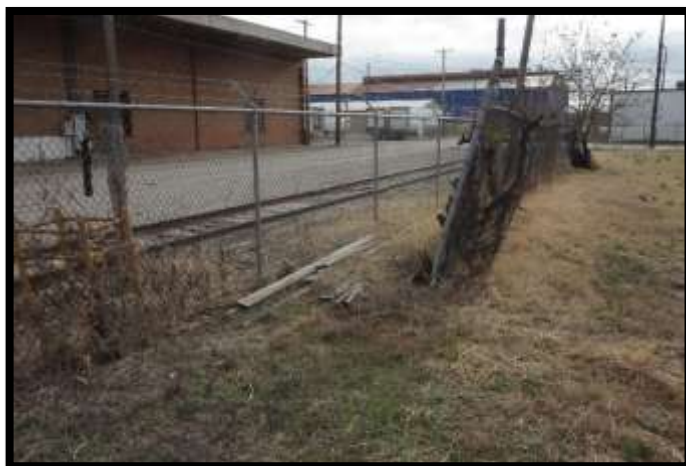
Photograph 65: Older and newer fence near former BV&G Truck Service buildings and along railroad tracks (view northeast).

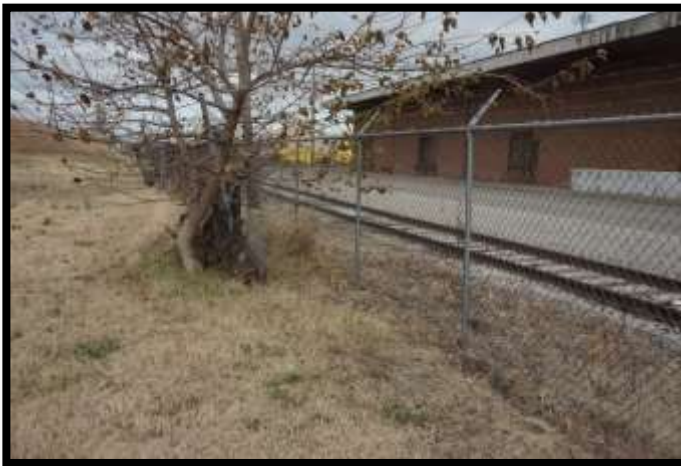
Photograph 66: Older and newer fence near former BV&G Truck Service buildings and along railroad tracks (view northwest).

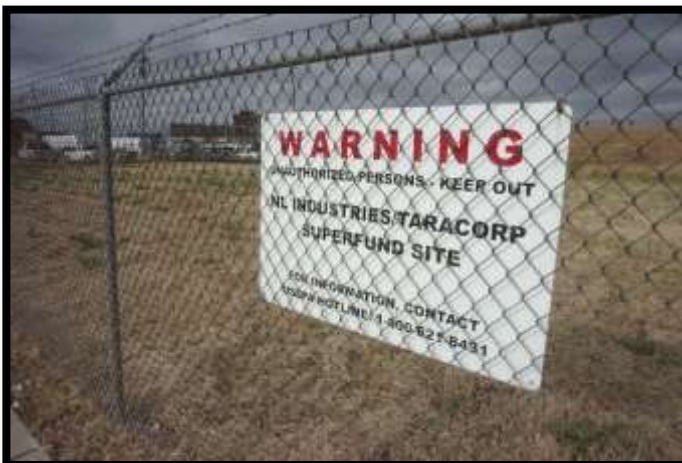
Photograph 80: Warning sign on fence along State Street.

Evidence of tampering	Yes	No		
Securely affixed to fence	Yes	No	One of the four fasteners was missing from one of the warning signs along State Street.	A fastener was purchased and installed to completely reaffix the warning sign to the fence.
Signs legible	Yes	No		
Comments				
<b>Access Road</b>				
Evidence of settlement or deterioration	Yes	No		
Comments			No access road problems.	
<b>Taracorp Pile - Vegetation</b>				
Adequate growth of vegetation	Yes	No	Growth abundant, except small strip of ground between the sidewalk and State Street.	The Group's contractor, Munie Greencare Professionals (Munie), reseeded this area on November 12, 2020.
Adequate diversity of vegetation	Yes	No	Wildflowers and crown vetch observed on cap.	
Evidence of stress	Yes	No		
Presence of trees, shrubs, woody bushes	Yes	No	No trees, shrubs, etc. observed.	
Need for mowing/maintenance	Yes	No		
Comments			The Group's contractor, Munie, cut the vegetation on the flat parts of 1555 State Street property and applied herbicide on October 27, 2020.

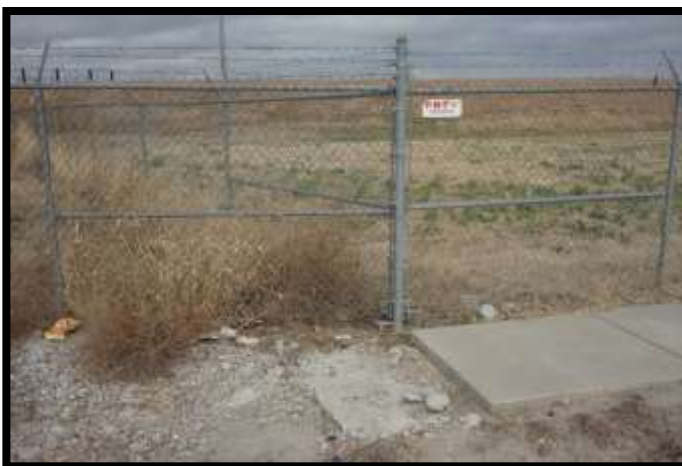
Photograph 82: End of concrete sidewalk at former Rich Oil property.

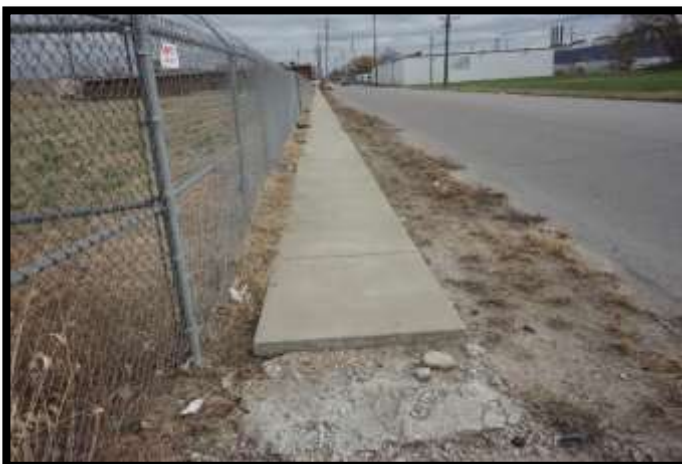
Photograph 84: End of concrete sidewalk at former Rich Oil property.

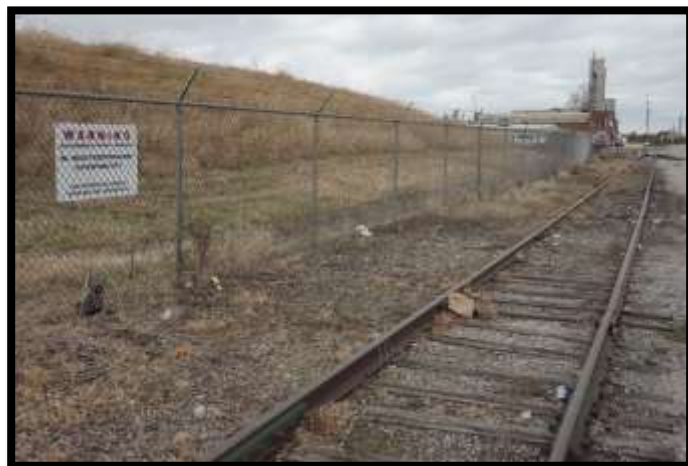
Photograph 93: Warning sign on fence along railroad tracks near 16<sup>th</sup> Street and Edison Avenue.

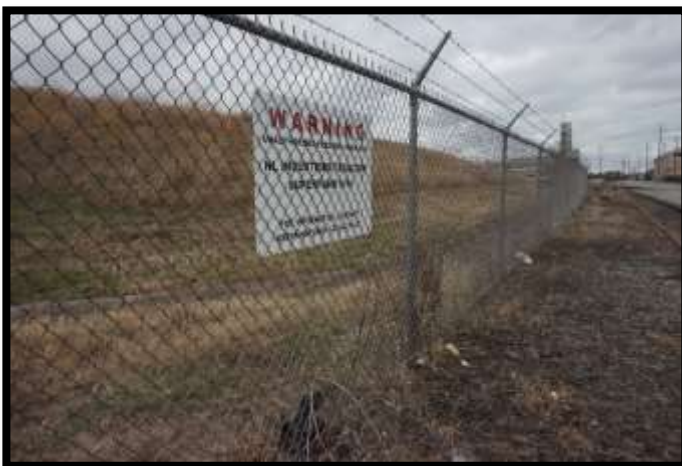
Photograph 94: Warning sign on fence along railroad tracks near 16<sup>th</sup> Street and Edison Avenue.

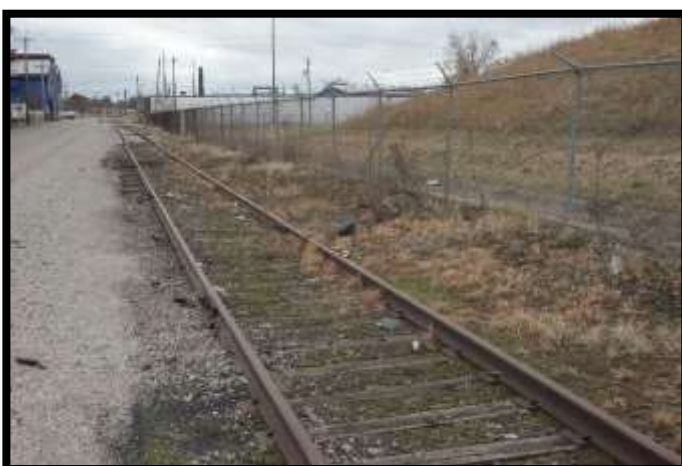
Photograph 96: Fence and vegetation along railroad tracks and 16<sup>th</sup> Street.

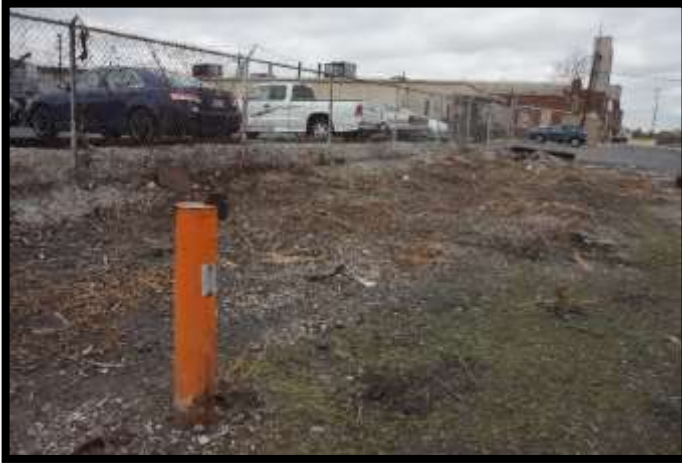
Photograph 97: Monitoring well MW-101.

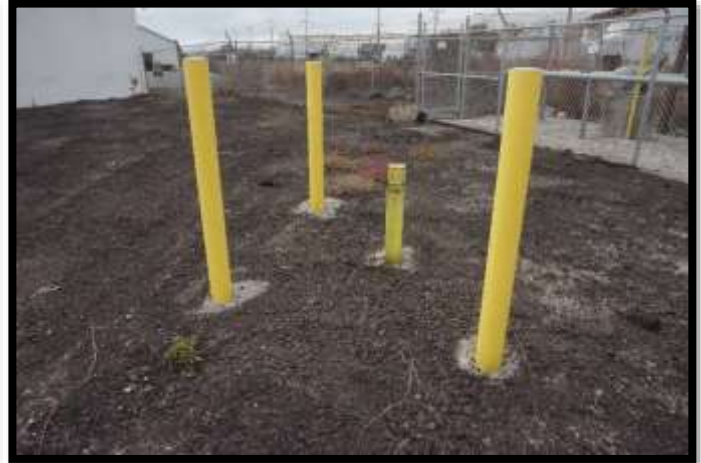
Photograph 98: Recently constructed bollards around monitoring well MW-105D.

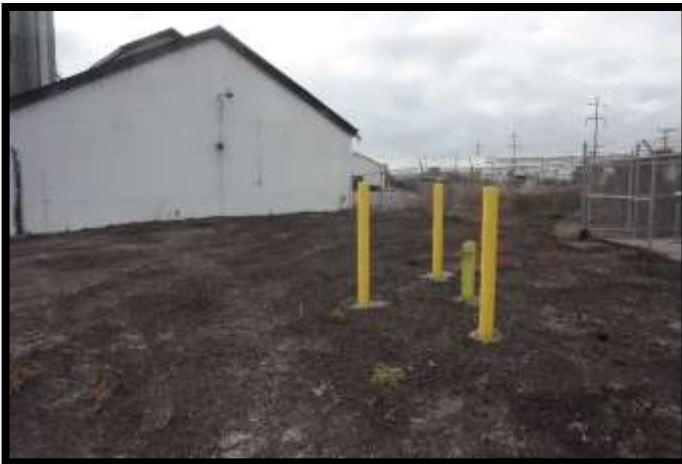
Photograph 99: Recently constructed bollards around monitoring well MW-105D.

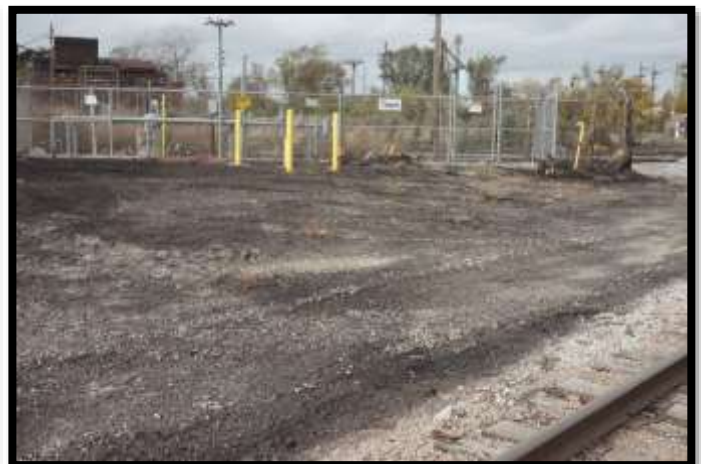
Photograph 100: Recently constructed bollards around monitoring well MW-105D.

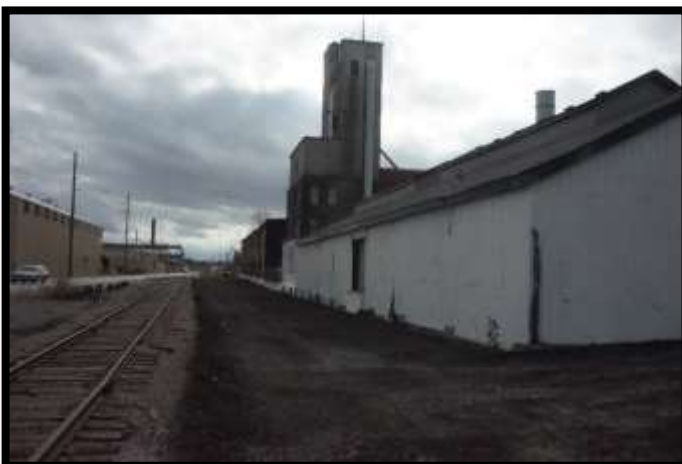
Photograph 101: Area along Mayco property, railroad tracks.

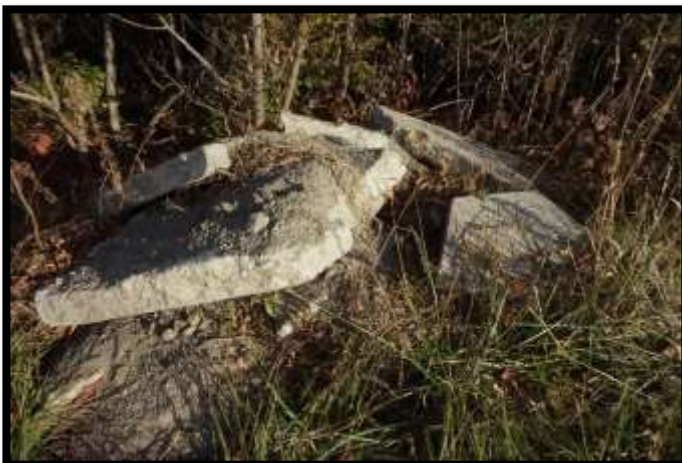
Photograph 10: Schaeffer Road property, concrete debris along roadway.

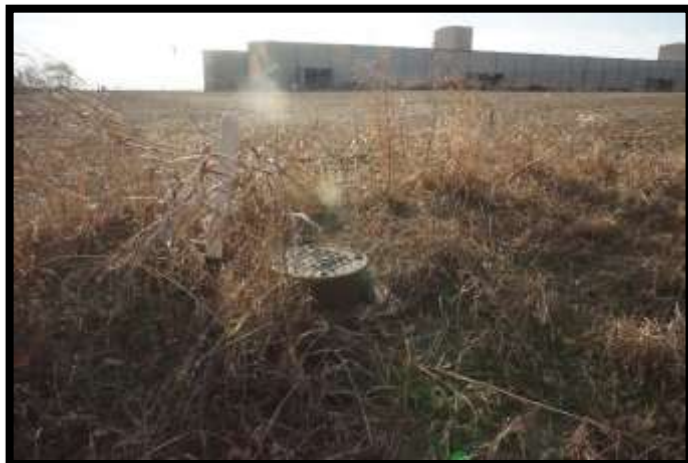
Photograph 19: Schaeffer Road property, sanitary sewer manhole.

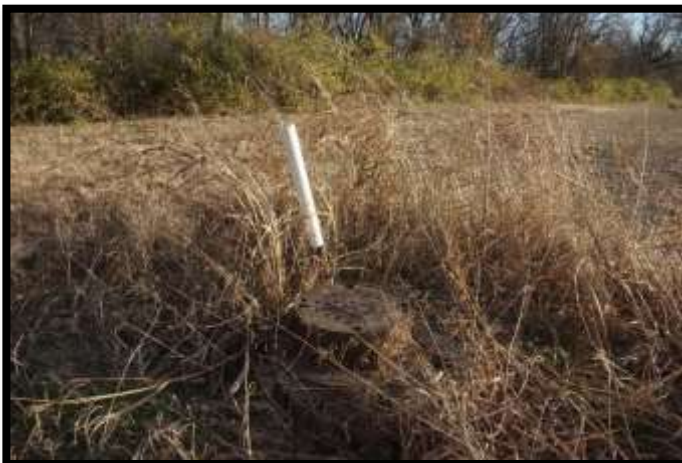
Photograph 20: Schaeffer Road property, sanitary sewer manhole.

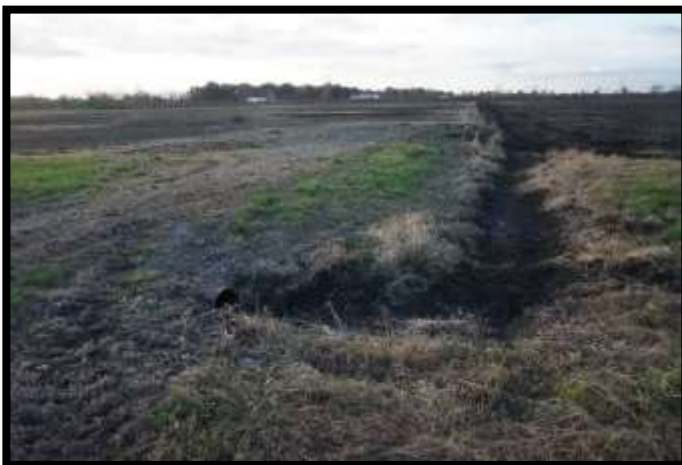
Photograph 2: Sand Road property, stormwater drainage ditch.

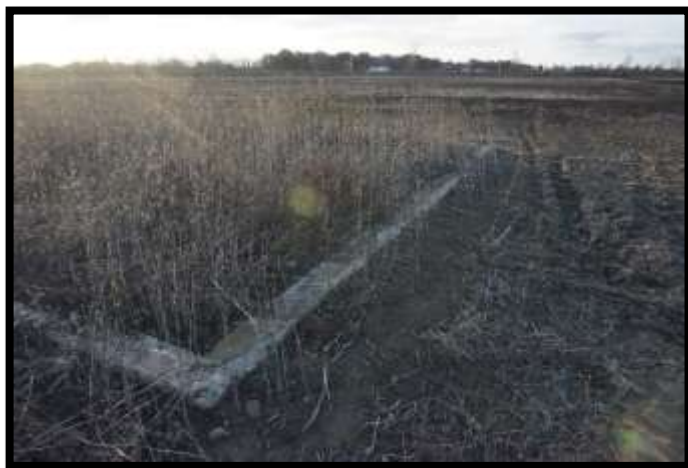
Photograph 3: Sand Road property, concrete foundation.

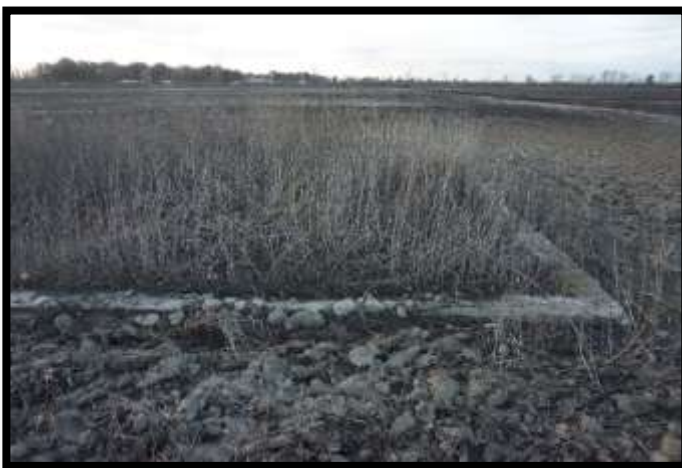
Photograph 4: Sand Road property, concrete foundation.

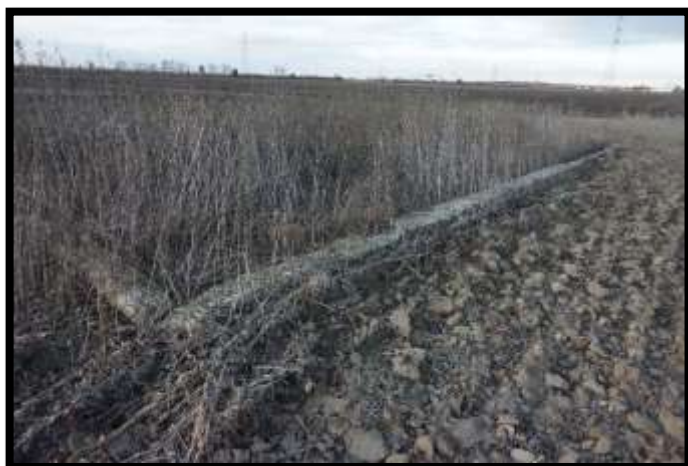
Photograph 5: Sand Road property, concrete foundation.

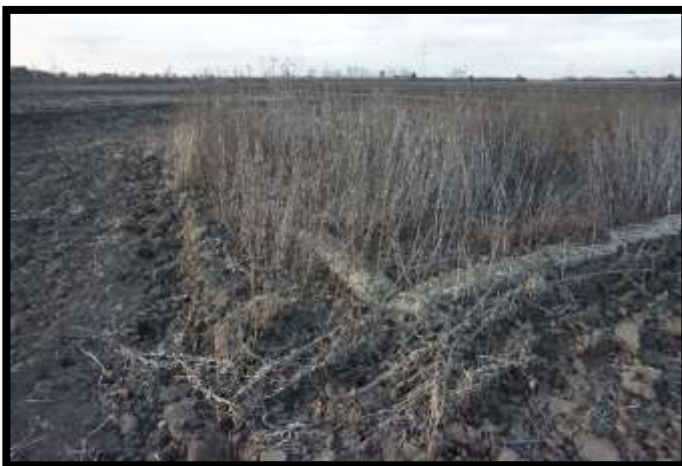
Photograph 6: Sand Road property, concrete foundation.

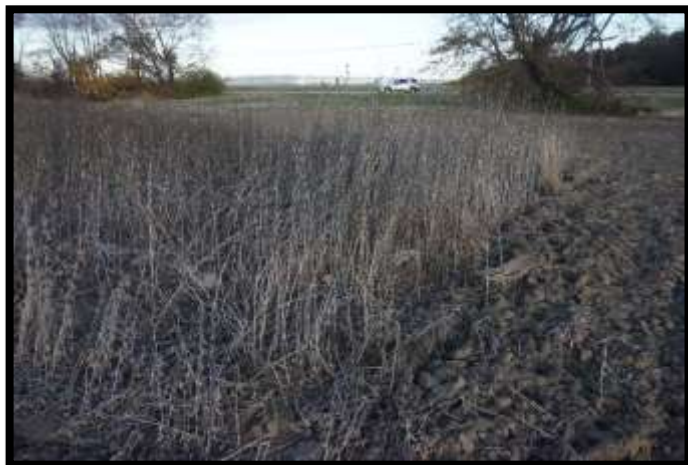
Photograph 7: Sand Road property, concrete foundation.

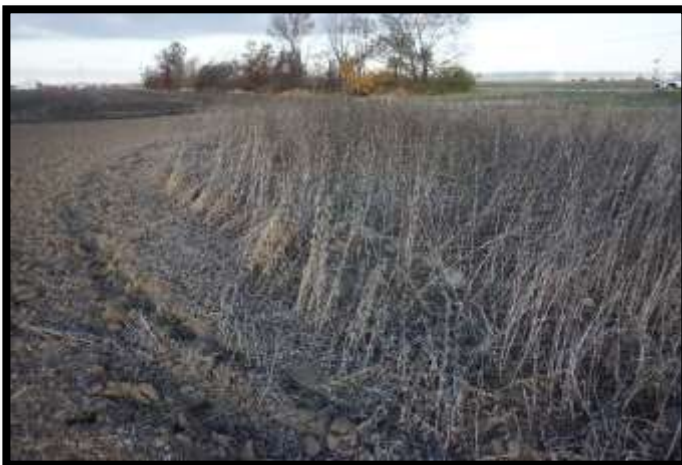
Photograph 8: Sand Road property, concrete foundation.

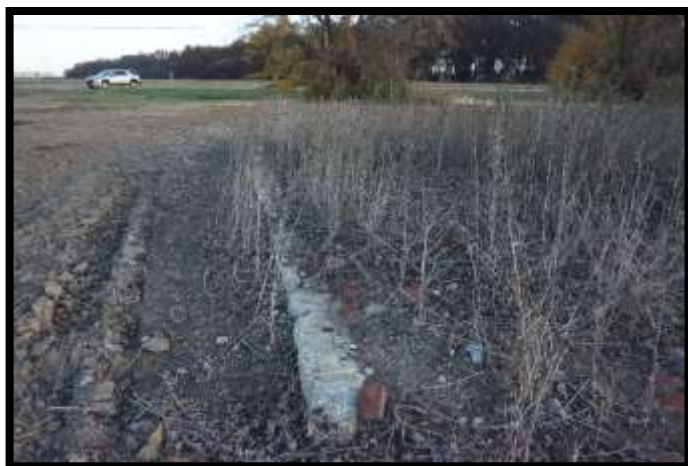
Photograph 9: Sand Road property, concrete foundation.

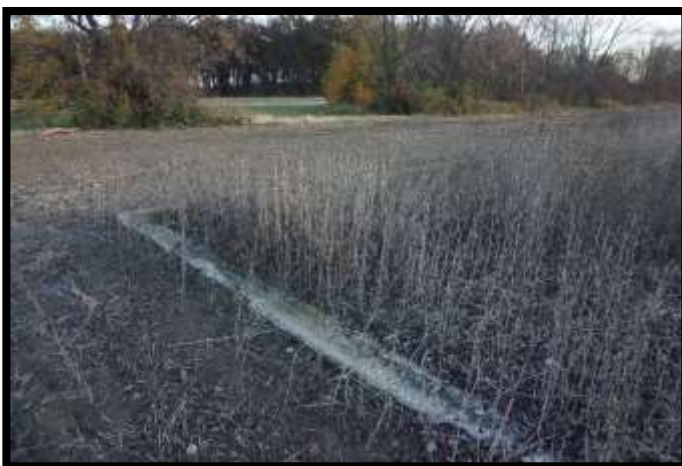
Photograph 10: Sand Road property, concrete foundation.

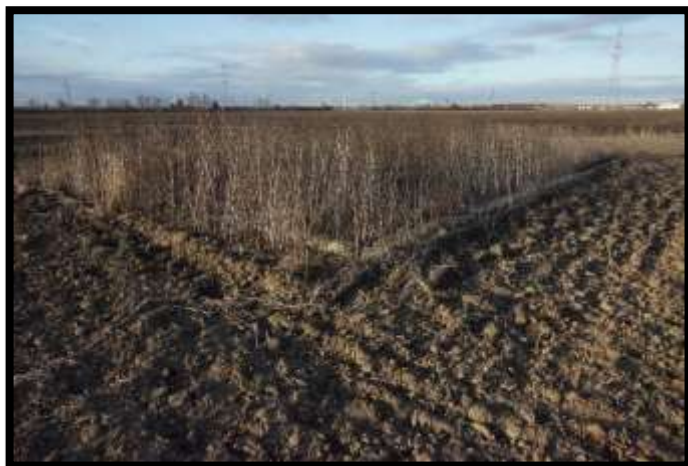
Photograph 11: Sand Road property, concrete foundation.

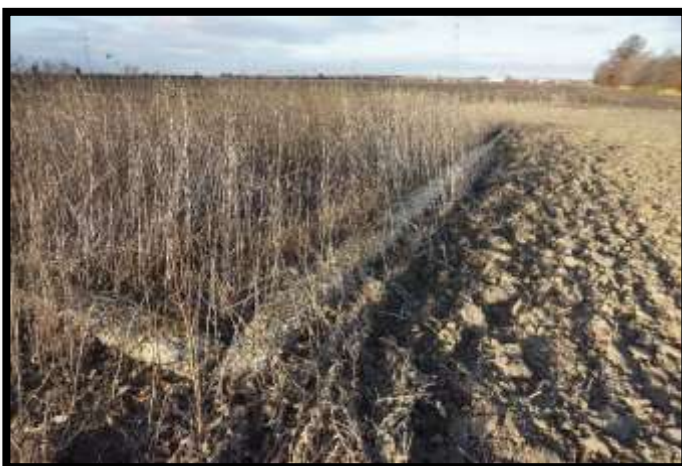
Photograph 12: Sand Road property, concrete foundation.

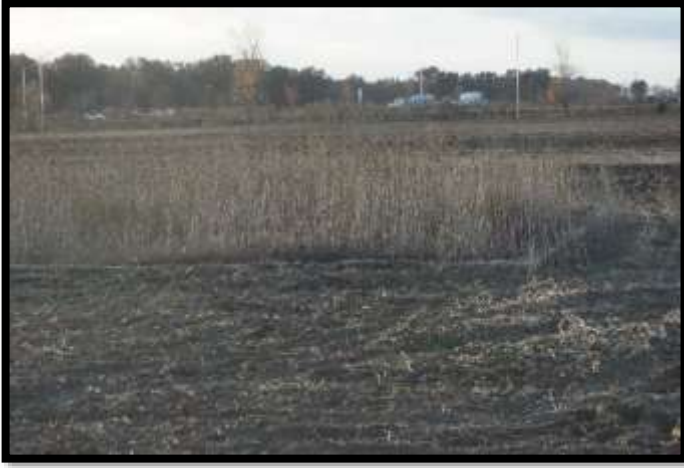
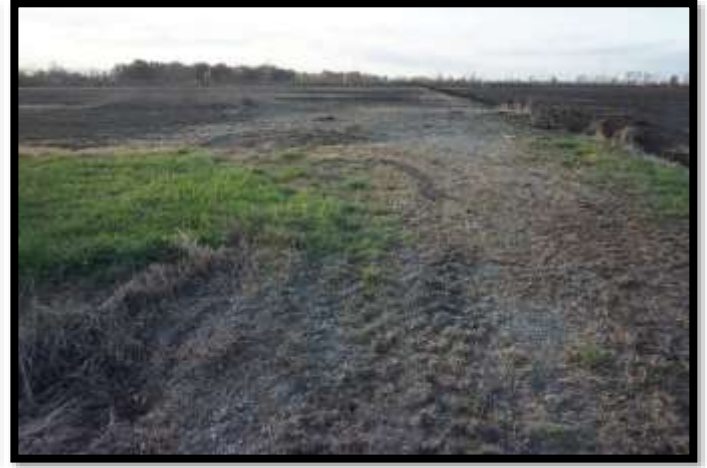
Photograph 13: Sand Road property, concrete foundation. Photograph 14: Sand Road property, entrance road.

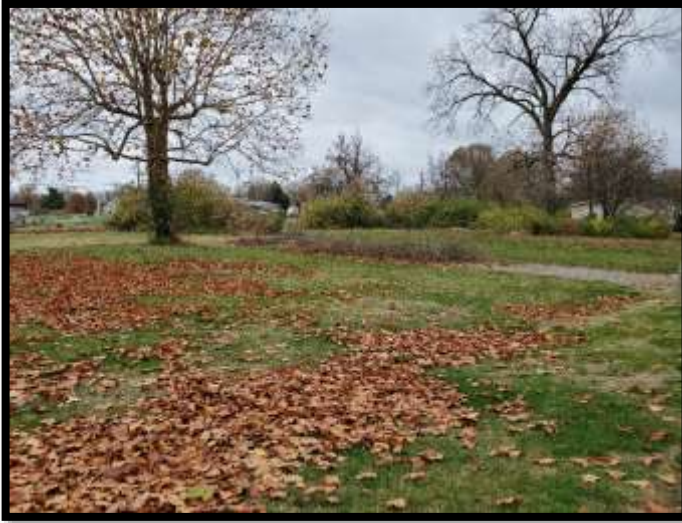
Photograph 1: 206 Terry Street property (Eagle Park Acres).

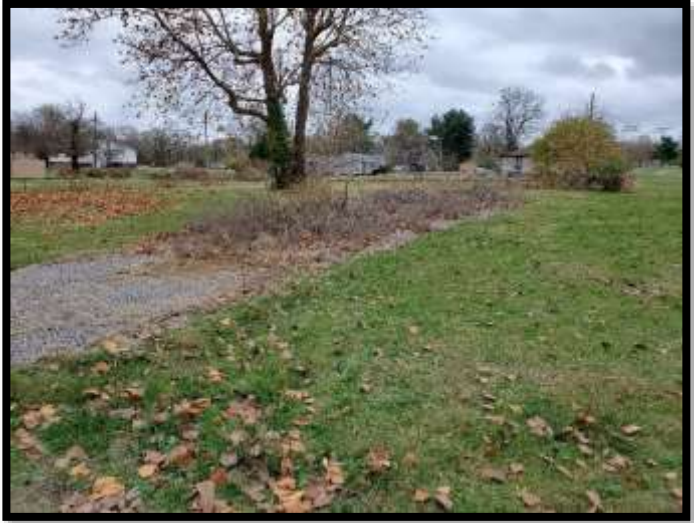
Photograph 2: 206 Terry Street property (Eagle Park Acres).

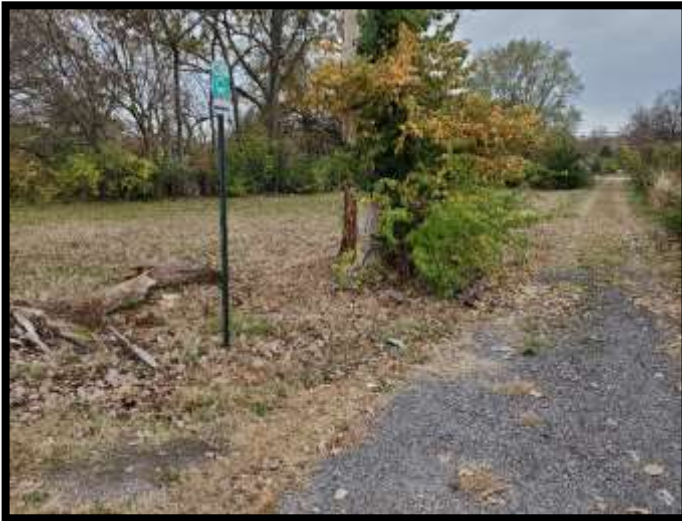
Photograph 3: Harrison Street property (Eagle Park Acres).

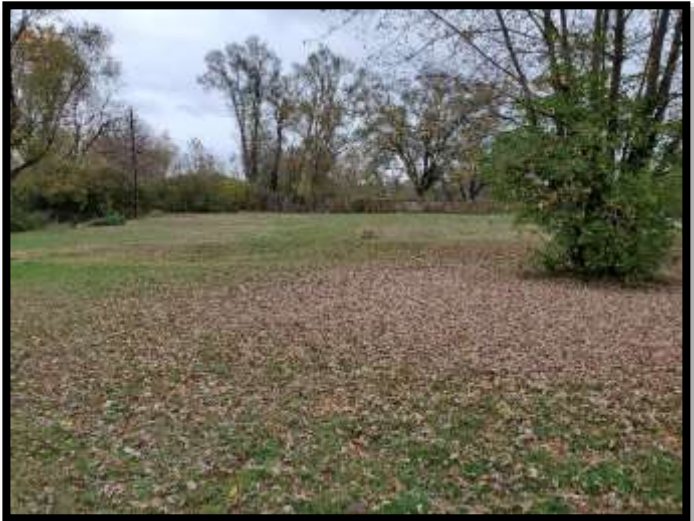
Photograph 4: Harrison Street property (Eagle Park Acres).
